## Sotin, Main Altar of Church of the Blessed Virgin Mary Help of Christians

Sotin, glavni oltar crkve Blažene Djevice Marije Pomoćnice kršćana  
Sotin, Main Altar of Church of the Blessed Virgin Mary Help of Christians

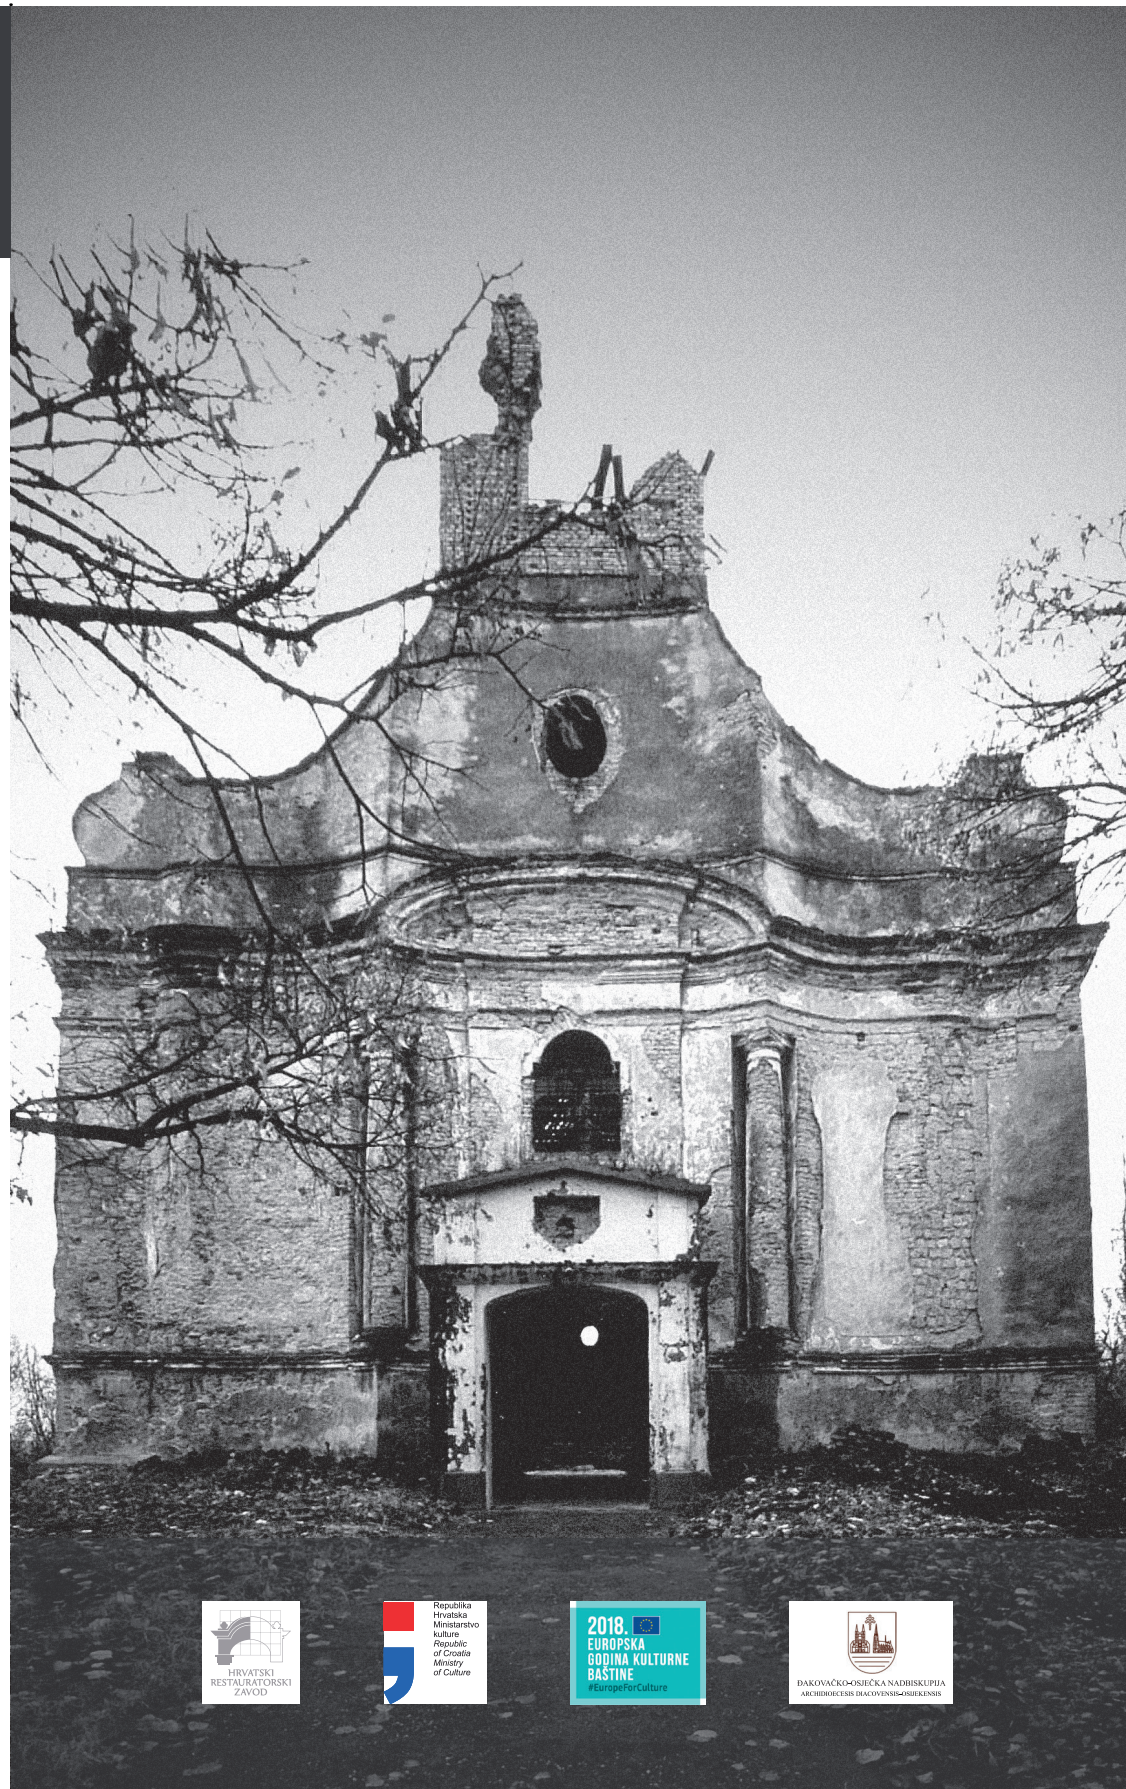
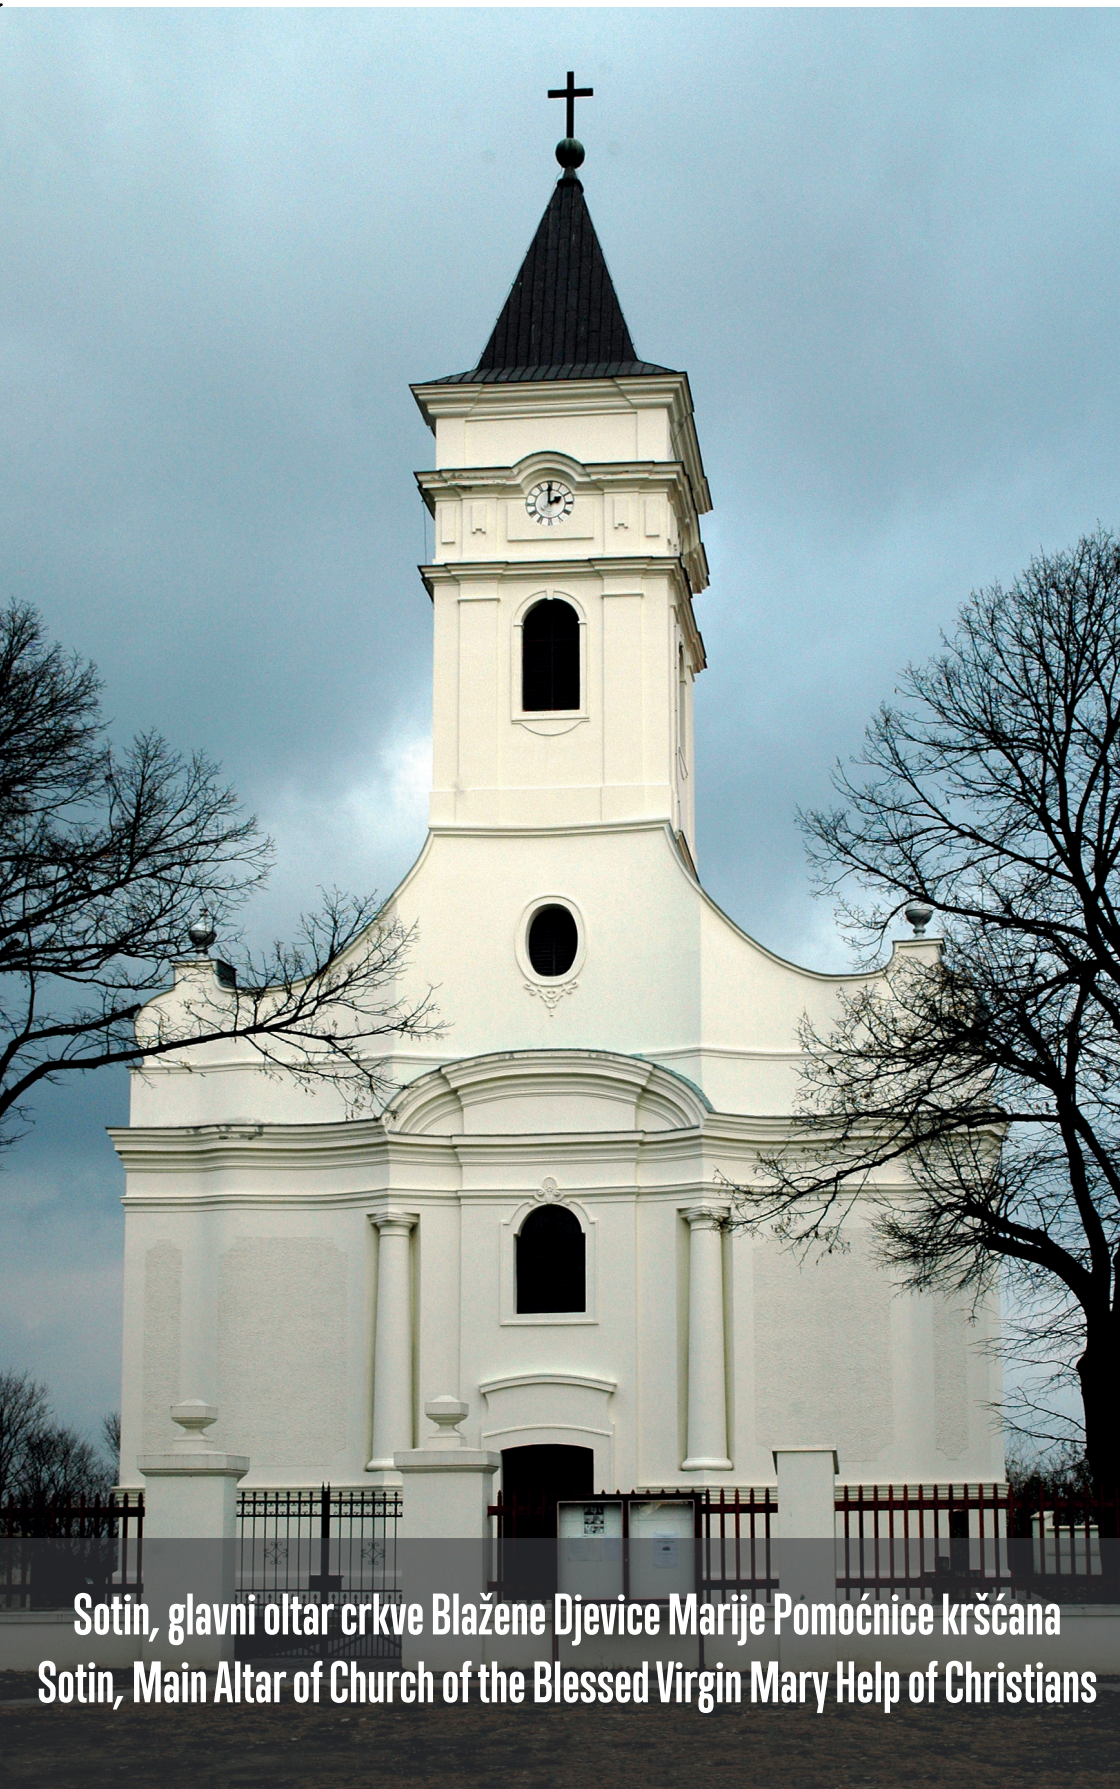
The main altar in Sotin is a single-tiered retable with an attic. Rising above the side pedestals and the altar stone with a typical concave-convex shape is a predella with consoles that carry columns and serve as pedestals for sculptures of St. Joachim

and St. Anne. The central focus of the retable is the oil-on-canvas painting of the Blessed Virgin Mary, one of numerous similar copies based on the template by the German painter Lucas Cranach. During the construction of the altar, special attention was paid to the design of the tabernacle in the form of a small *tempietto*. The altar was constructed using a special technique that combines plaster, various pigments and animal glue to imitate different types of marble.

In 1991, during the Homeland War in Croatia, the parish church in Sotin was heavily damaged. The altar was mechanically damaged in several places, the wooden structure was desiccated or burnt, the layer of rough supporting plaster was separated from the wooden structure, and the layer of stucco marble was cracked, mechanically damaged, or completely gone. Statues of St. Joachim and St. Anne were missing, and only a few fragments of the angel sculptures remained.

During the European Year of Cultural Heritage comprehensive conservation of the main altar from the church in Sotin has been completed. The work, carried out from 2007 to 2018, included the construction of the missing wooden structure, rendering of the rough supporting plaster, replacing a layer of stucco marble with different patterns on all elements of the altar architecture, and creating a facsimile of the sculptures. The abovementioned work, as well as all the technical and technological solutions that came from extensive research, were carried out by the staff of the Department for Stucco at the Croatian Conservation Institute. The complexity of the work is evident in the fact that only a handful of Central European workshops specialize in the conservation of art pieces made using this technique.

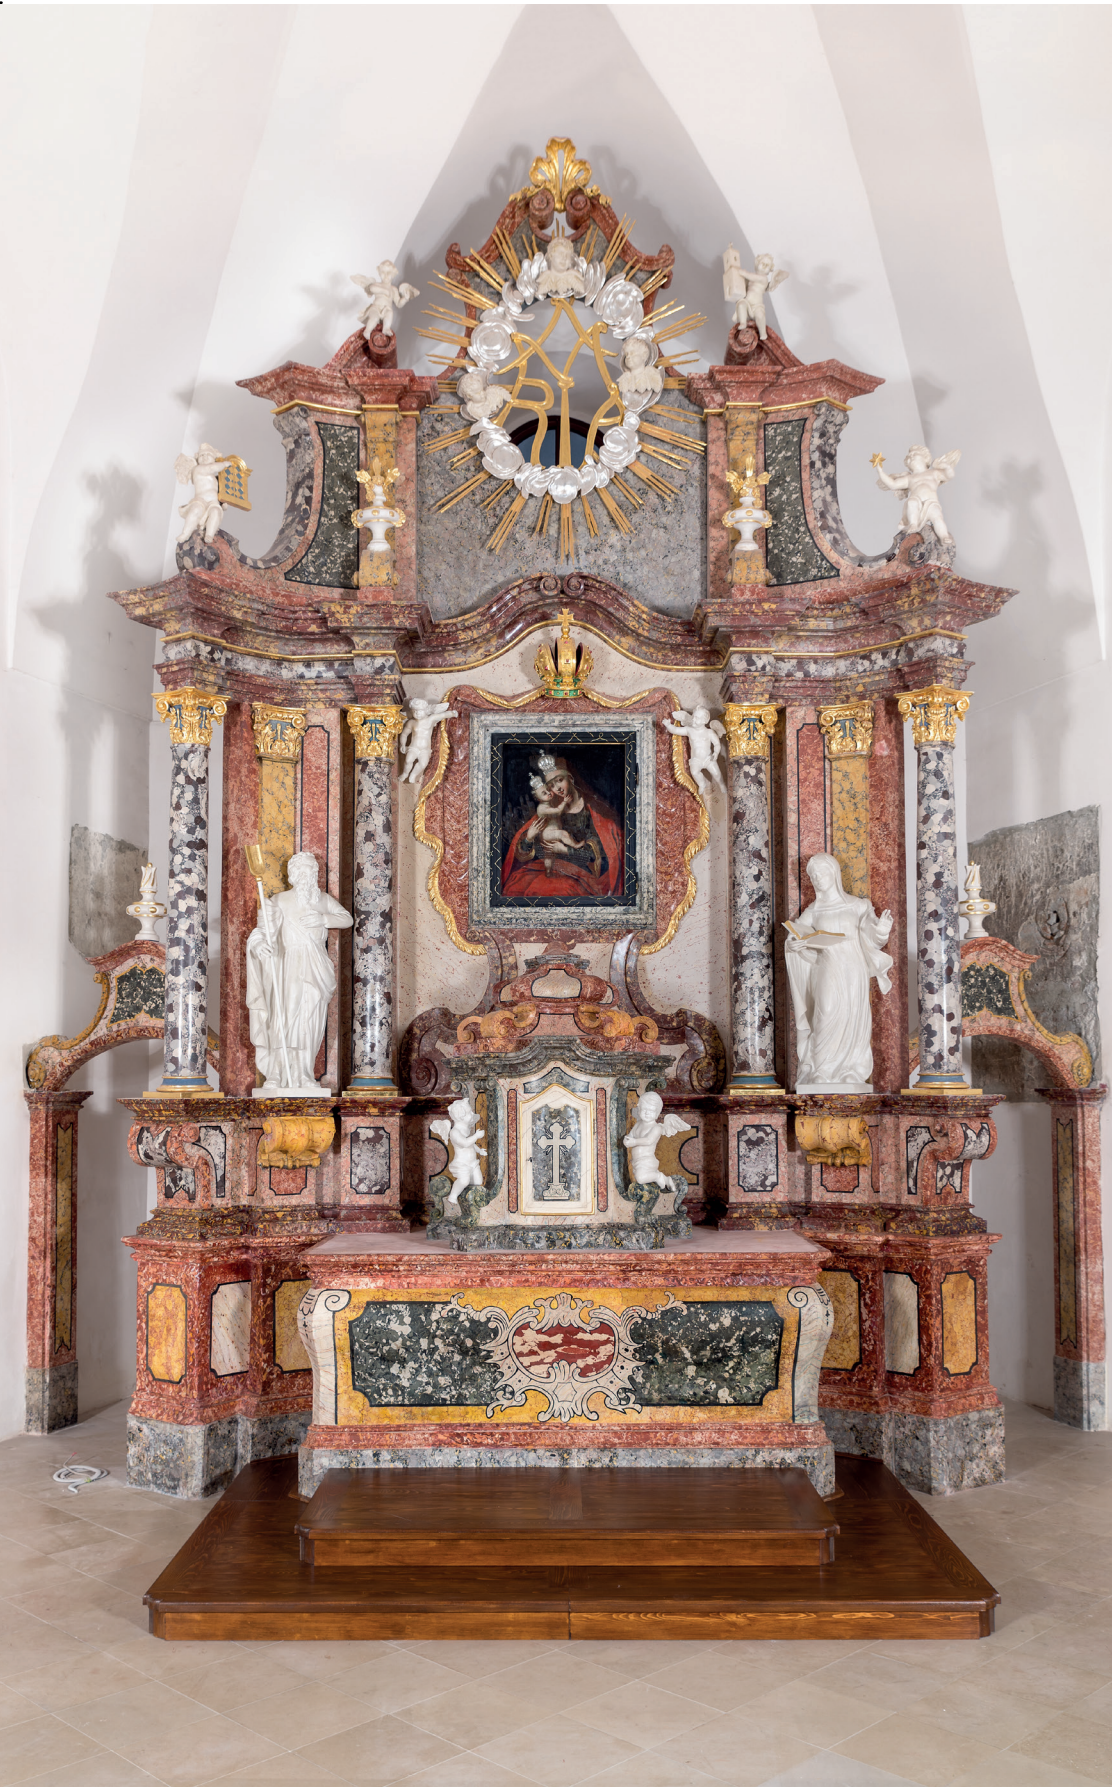
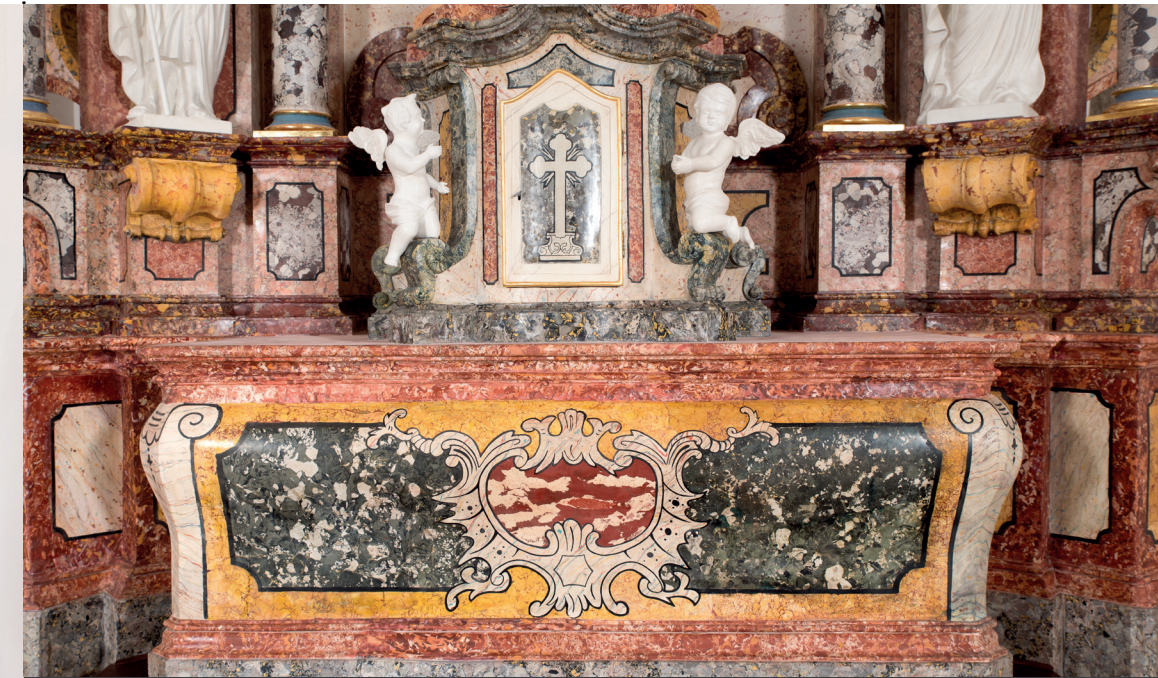
Stucco marble is a special technique that combines plaster, various, mostly earthy, pigments and animal glue to imitate different types of marble. Pigmented plaster pastes are kneaded, bent, cut, and combined to achieve marble-like structures: gently streaked light marble, more intensely pigmented breccia, and multicolored stone structures. The stucco is placed on a wooden substructure on which a layer of rough supporting plaster had been applied. The desired effect – imitating multicolored polished marble – is achieved by cutting the stucco marble using special tools, polishing and sanding it multiple times using a pumice stone and super fine sandpaper, and finally polishing it with wax. Making stucco marble is a demanding and long technological process requiring high levels of craftsmanship. This tech-

The conservation of stucco marble includes work on the wooden substructure, fixing the existing rough supporting plaster and applying a new layer, as well as shaping and sanding it, adding the final layer of stucco marble that is then sanded and polished. In order for the shape and colors of the reconstructed part of the stucco marble to match the original material, numerous testing during all stages of the process is required for each sample.
